X. THE VENTURA RIVER

California, Ventura County: Ventura River Watershed

HYDROGEOMORPHIC CLASSIFICATION AND ASSESSMENT OF FUNCTIONS AND VALUES OF THE WETLANDS OF THE VENTURA RIVER WATERSHED

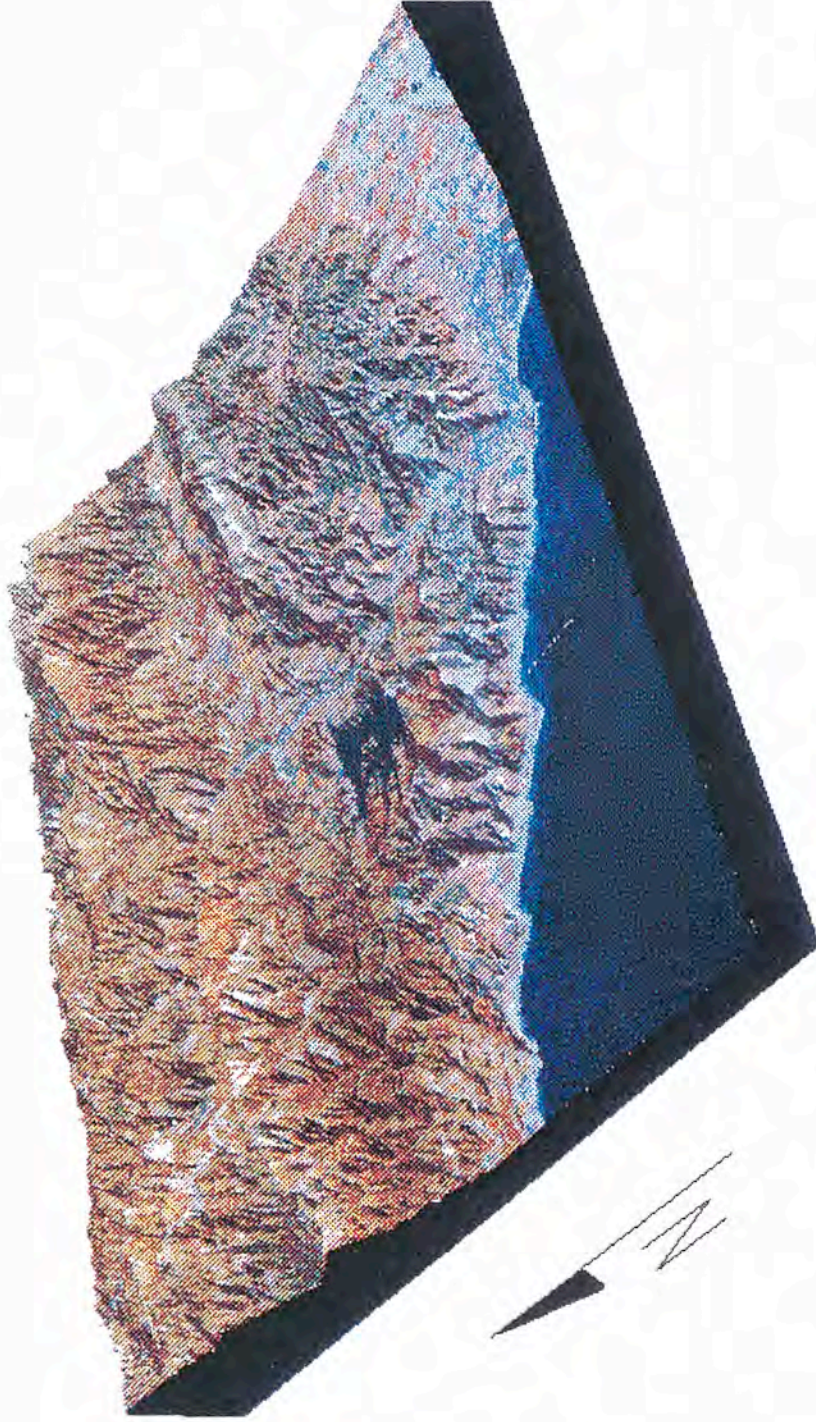
Fig. X-2. VENTURA RIVER WATERSHED THREE-DIMENSIONAL RELIEF MAP. View from the Pacific Ocean northward into Ventura River system. Processed image is a false-color-infrared composite (Landsat MSS Bands 7,5, and 4 rendered as red, green, and blue, respectively) for December 17, 1982. The Landsat image has been draped over a digital elevation model for the basin. Exaggerated vertical elevation emphasizes the rapid rise of the terrain from sea level to over 1800 m. The relatively flat area in the east-central part of the basin is the Ojai Valley.

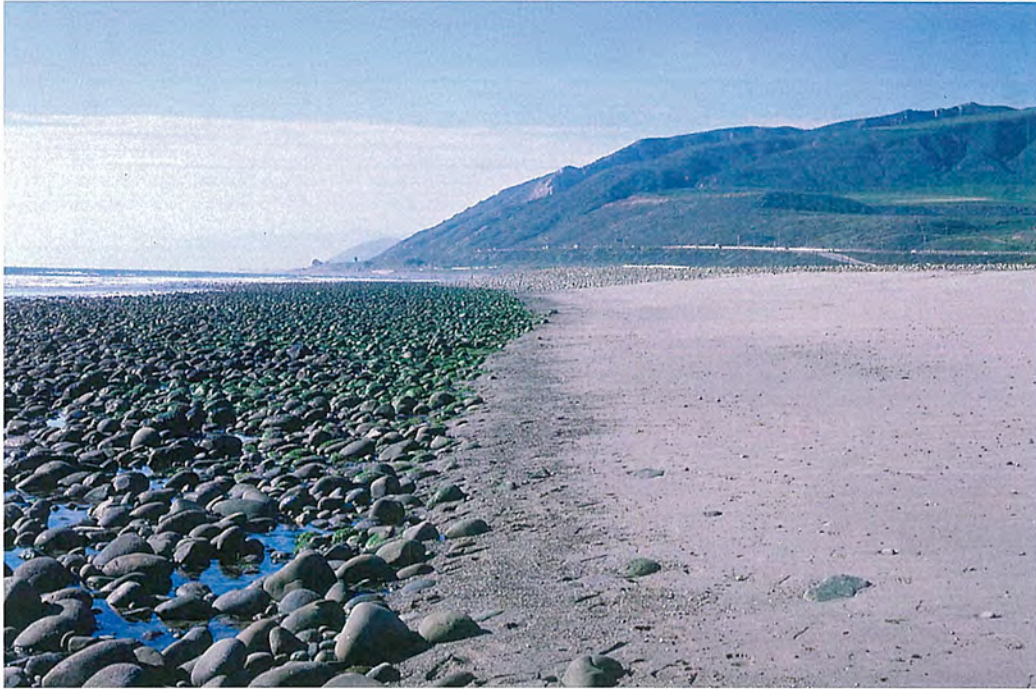
FIG. X-6a VENTURA SITE D: VENTURA RIVER MOUTH AREA. View westward across marine wetlands at low tide along delta of the Ventura River.

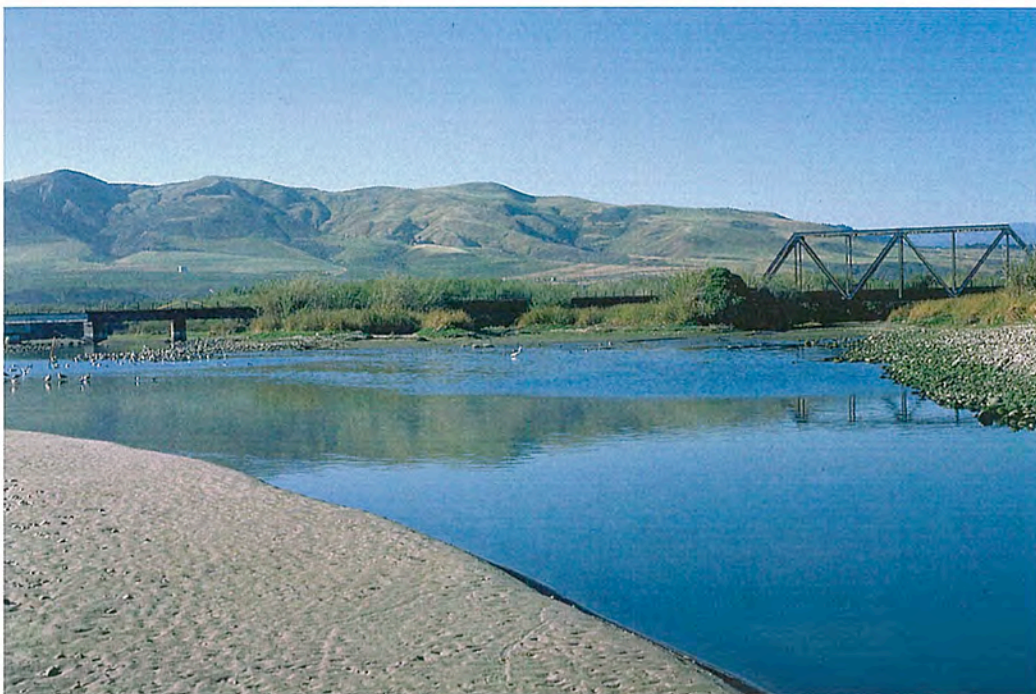
FIG. X-6b VENTURA SITE D: VENTURA RIVER MOUTH AREA. View of the Ventura River Estuary, northwestward from mouth of river-estuary toward railroad bridge.

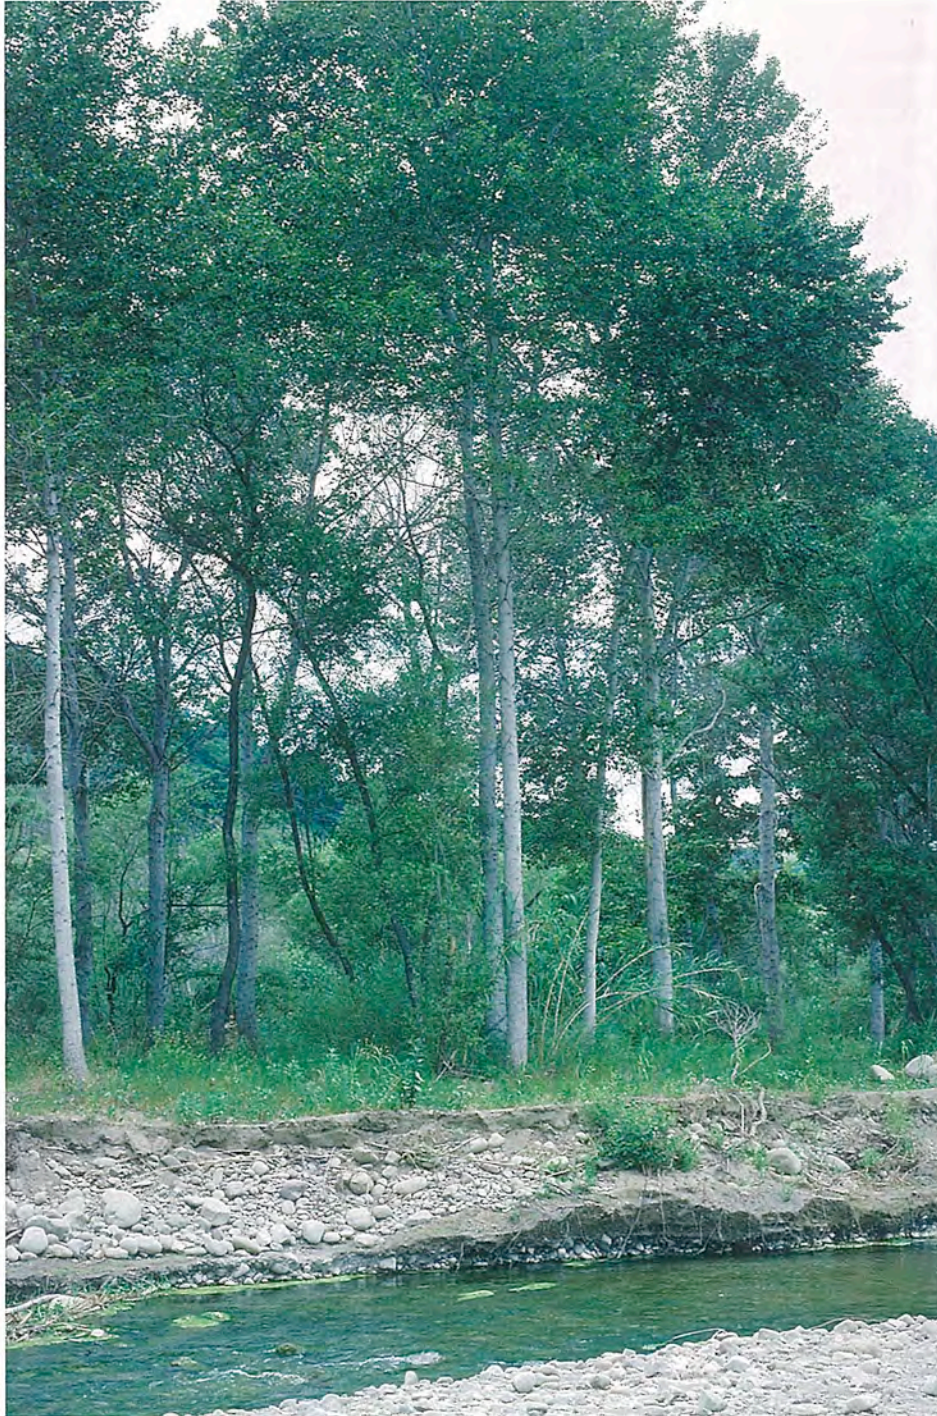
FIG. X- 8 . VENTURA SITE A: SAN ANTONIO CREEK, CASITAS SPRINGS AREA. View northwestward across riverine wetlands toward palustrine forested wetland dominated by *Populus balsamifera* ssp. *trichocarpa* (Black Cottonwood).

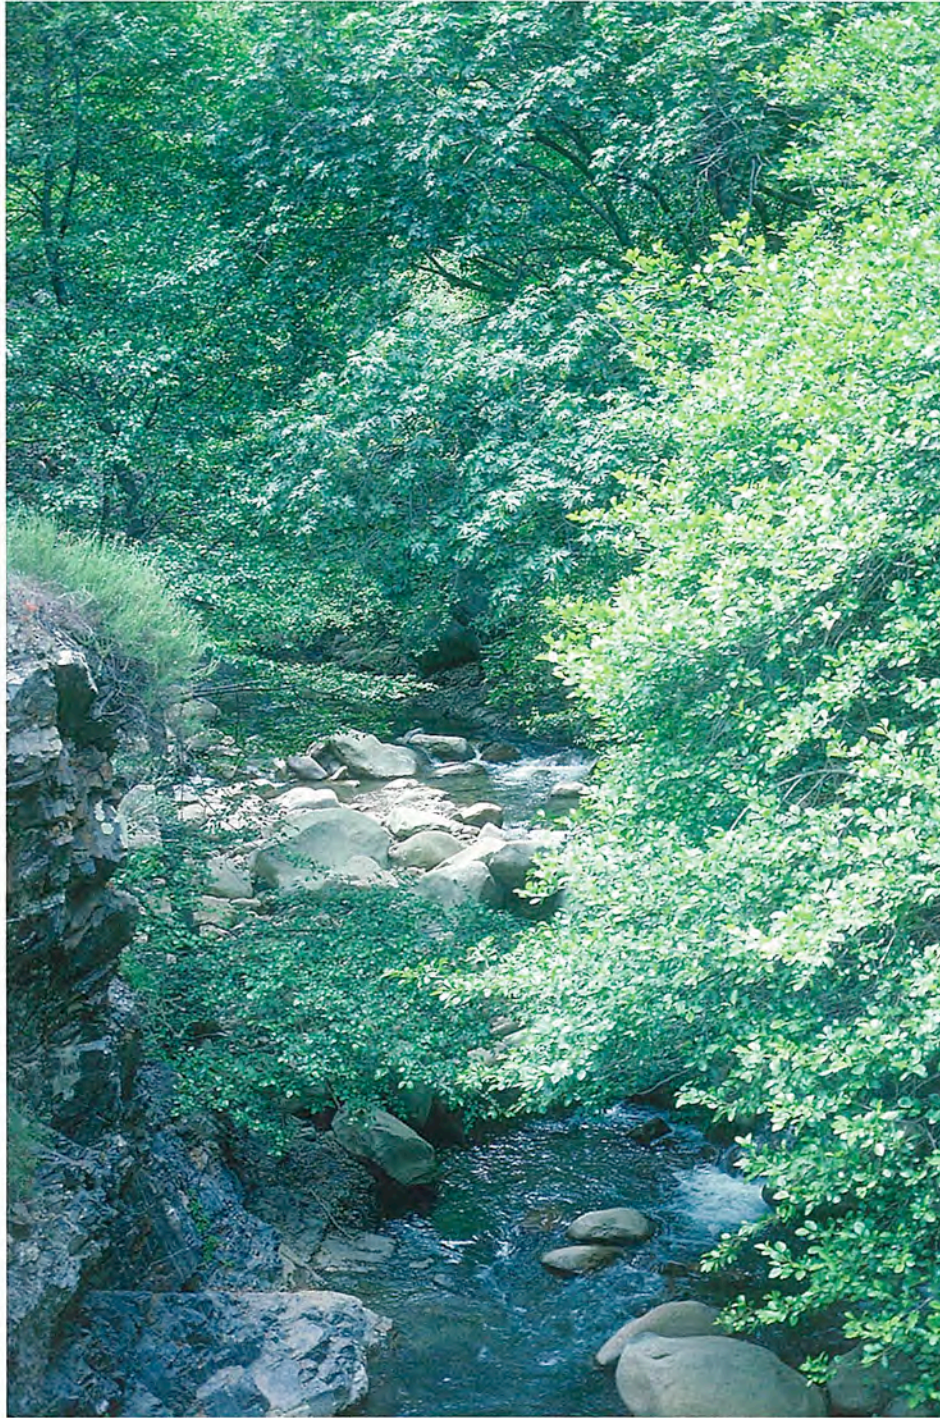
FIG. X-9. VENTURA SITE E: MATILIJA CREEK, WHEELER GORGE. View upstream along Matilija Creek. Palustrine forested wetland as illustrated is dominated by the broadleaved-deciduous tree *Alnus rhombifolia* (White Alder).

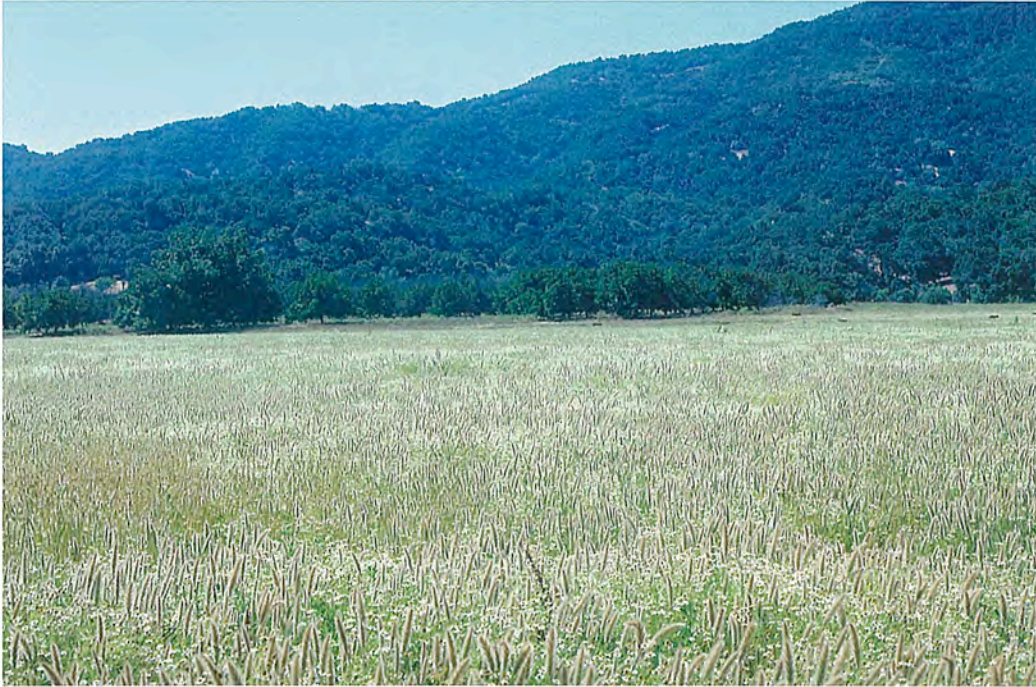
FIG. X-10a. VENTURA SITE F: UPPER OJAI VALLEY, VERNAL PLAIN. View from lower end of the montane valley, eastward along the long-axis of the vernal wetland plain.

One of the most unusual examples of a vernal habitat in this faulted region occurs near the east side of the drainage along Lion Fault. Site 162 (Fig. X-10) represents one of only two vernal plains observed in the southern California coastal drainages. At nearly 100 acres (40 hectares) it is the largest expanse of a vernal hydrogeomorphic habitat found in the Ventura River Watershed. The

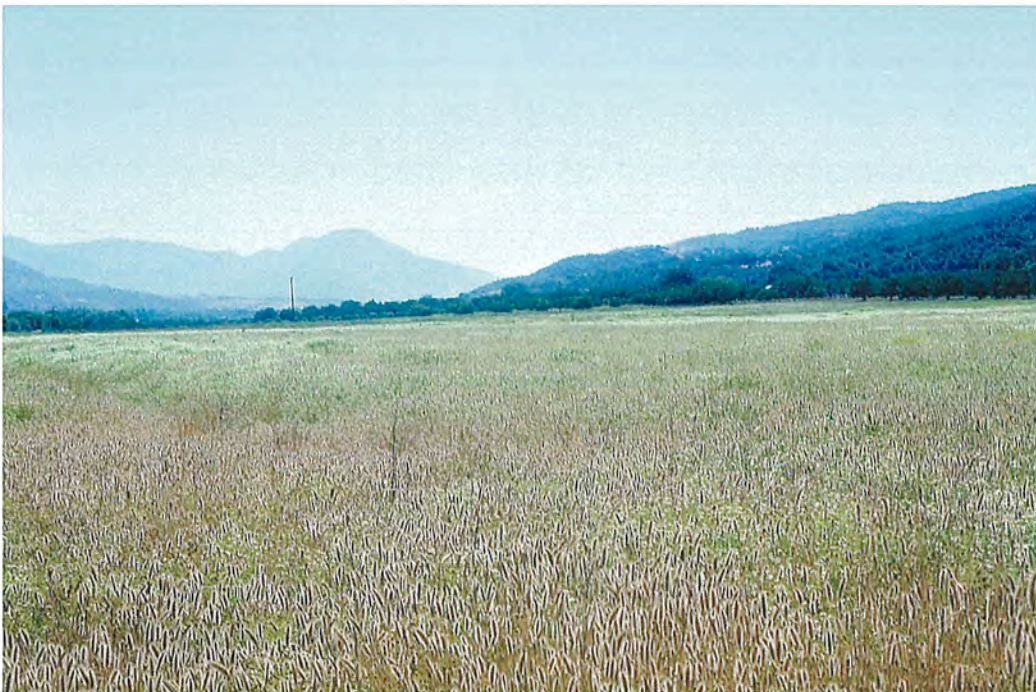
FIG. X-10b. VENTURA SITE F: UPPER OJAI VALLEY, VERNAL PLAIN. View southward across narrow-axis of vernal wetland plain, toward Sulphur Mountain. Palustrine emergent wetland is dominated by nonpersistent species such as *Polygonum monspeliensis* (Annual Beard Grass).

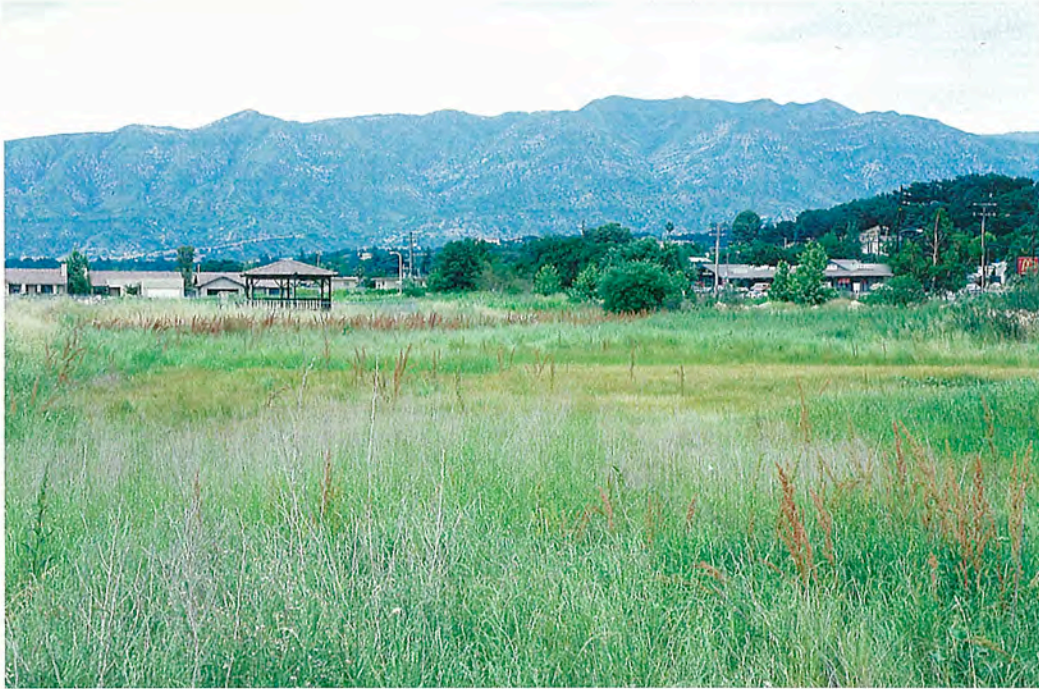
FIG. X-//a. VENTURA SITE C: OJAI VALLEY, MIRROR LAKE. View northward across remnant of a palustrine vernal lake in a desiccated state.

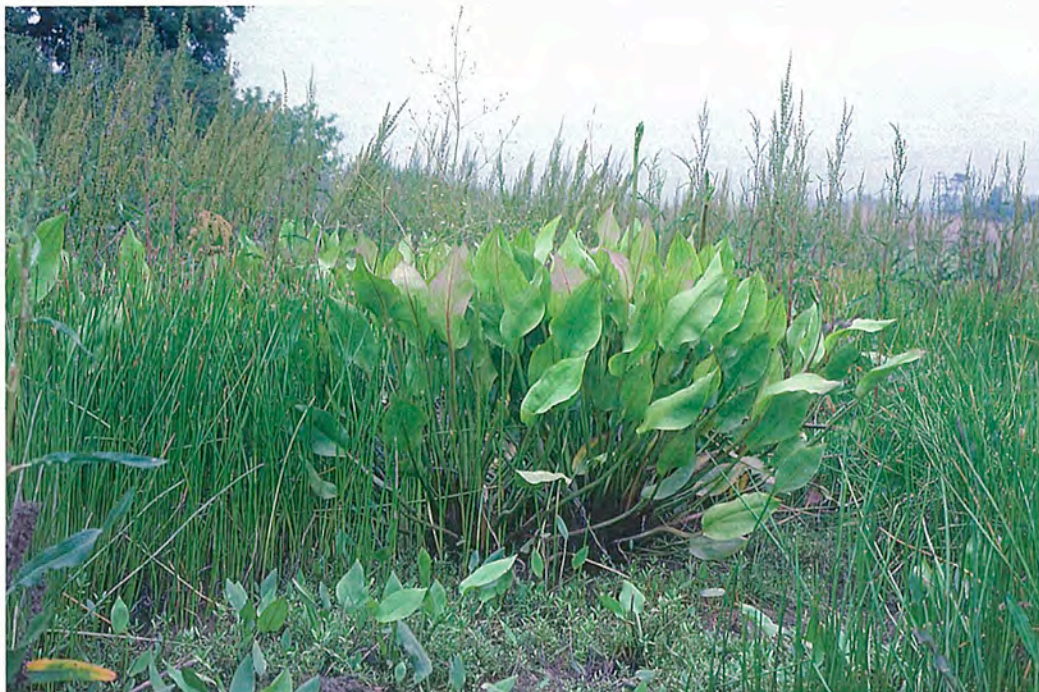
FIG. X-//b. VENTURA SITE C: OJAI VALLEY, MIRROR LAKE. View of vernal lake vegetation including *Alisma plantago-aquatica* (Water Plantain, center) and *Eleocharis macrostachya* (Spike Rush, left center).

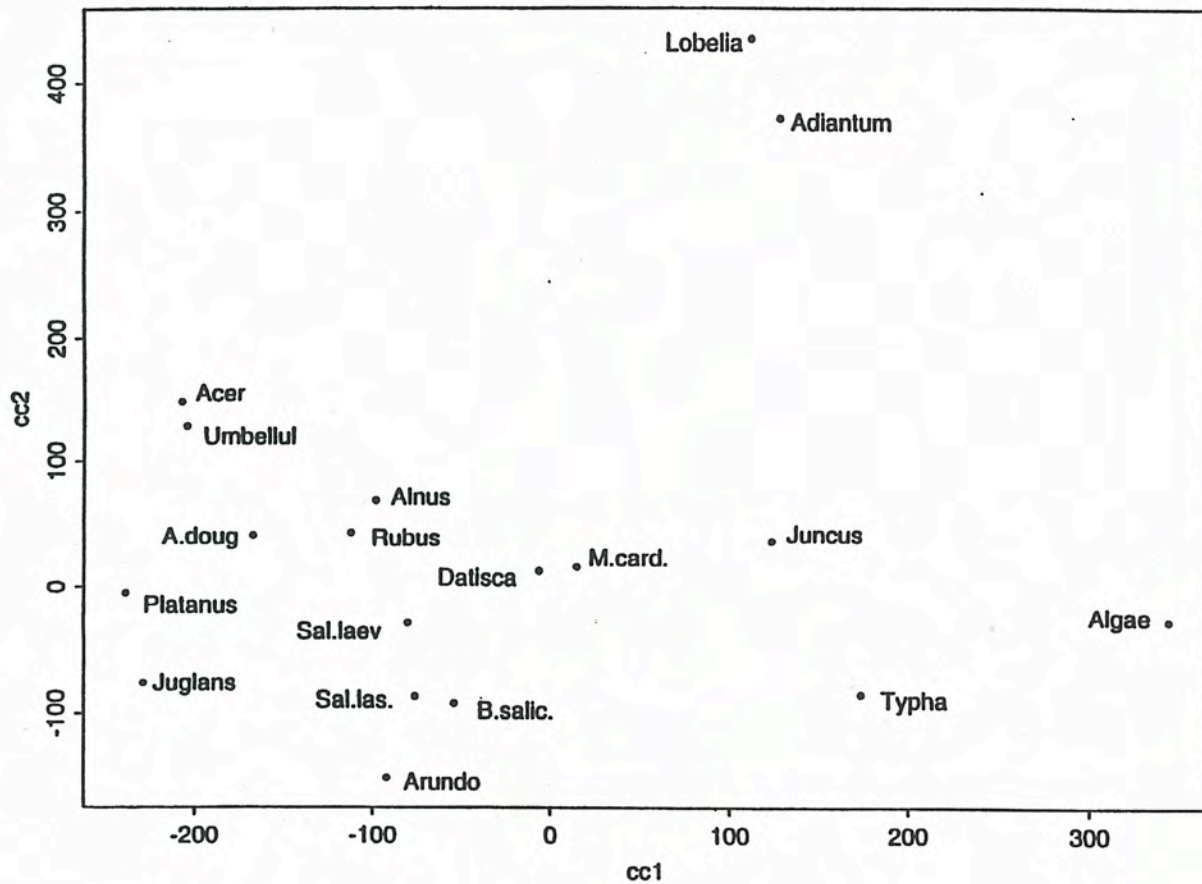
FIG. X-12. CANONICAL CORRESPONDENCES FOR CHARACTERISTIC VEGETATION TYPES OF THE VENTURA RIVER WATERSHED. Dry conditions are indicated by low abscissa (cc1) values. Ordinate values (cc2) are directly related to slope and elevation. Marine and Estuarine species were not included in this analysis.

Canonical correspondence analysis showed a very high correlation between canonical axis 1 (cc1 - Fig. X-12) and regime (-0.8453) and was also correlated with slope (0.2185). This axis accounted for 49.4% of the canonical variance. Axis 2 (cc2 - Fig. X-12) had a high correlation with slope (.6024) and elevation (.4413). This axis accounted for 30% of the canonical variance. The first axis (regime) was found to be significant at the 1% level.
